Manhole Inspection Summary

Manhole # S31EE2018MH

Location Address: **5701 MELROSE AVE**

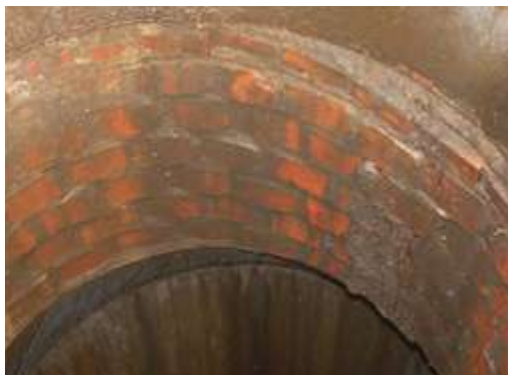
Defect

Condition: ☐ Sound ☐ Cracked ☒ **Root Intrusion** ☐ Loose Brick ☐ Deteriorated

Infiltration: ☐ None ☒ **Joint** ☐ Cracks ☒ **Mortar** ☒ **Roots** ☐ Wall

Adjustment root intrusion and infiltration.
Corbel infiltration.

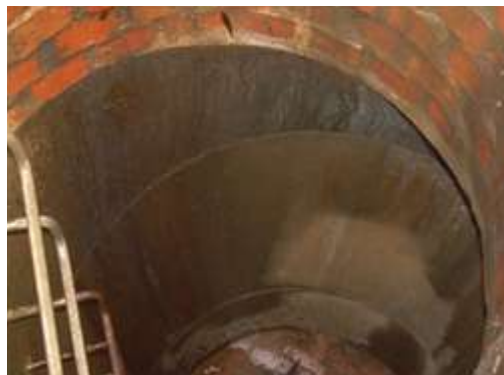
Defect

Infiltration: ☐ None ☒ **Joint** ☐ Cracks ☐ Mortar ☐ Roots ☒ **Wall**

Corbel and Barrel infiltration.

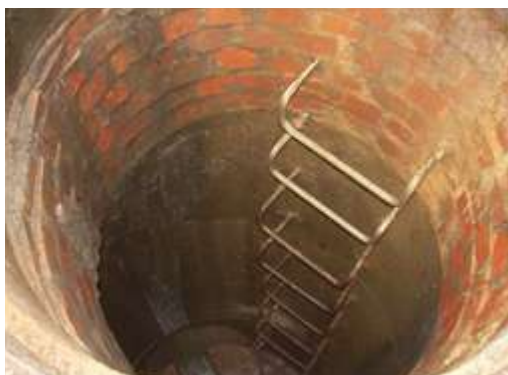
Defect

Adjustment, Corbel, and Barrel infiltration.

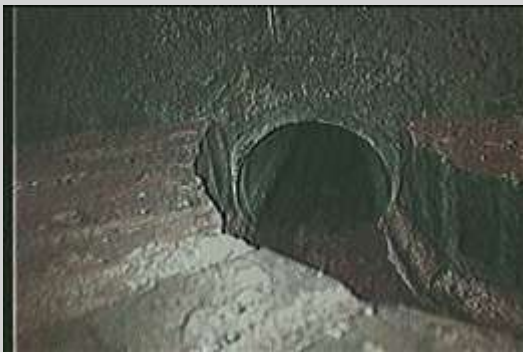
Pipe Out @ 12 O'Clock

Deposits: ☐ None ☐ Mud ☐ Sludge ☒ Debris ☒ Grease

Silt Depth: **0.5** (in.) Deposits Extent: **Light**

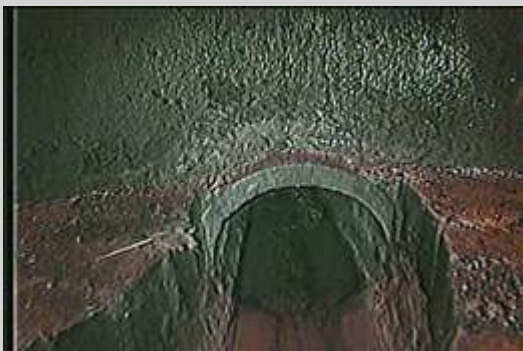
Pipe In @ 3 O'Clock

Deposits: ☐ None ☐ Mud ☐ Sludge ☐ Debris ☒ Grease
